Inspection report for the property at
60 Kisor Rd, Highland, NY

This report is prepared exclusively for **Malgorzata Sokolowska**
Inspected On: **11-21-2025**

NY ENVIRONMENTAL SEPTIC INSPECTIONS
(914) 233-7575

Septic Inspection Report

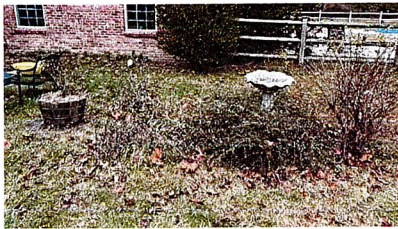
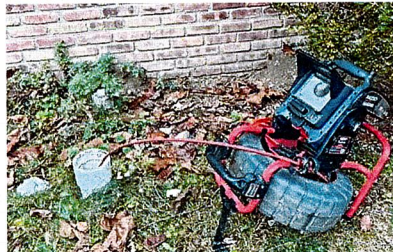
Access Point

Access Point: Inlet Lid Main Chamber Lid Outlet Lid Waste Line Clean Out

If cleanout is accessible: Interior Exterior

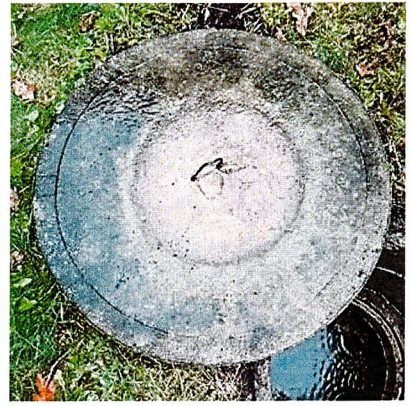
Lid Condition/Dimensions

Condition: Safe At Risk N/A

Dimensions: 38" Round concrete riser lid with hook

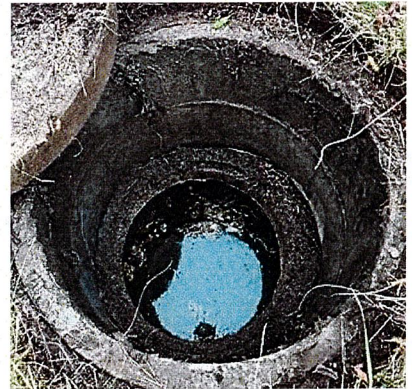
Riser Type: Plastic Concrete Block Brick Metal Other None

Dimensions: 24"

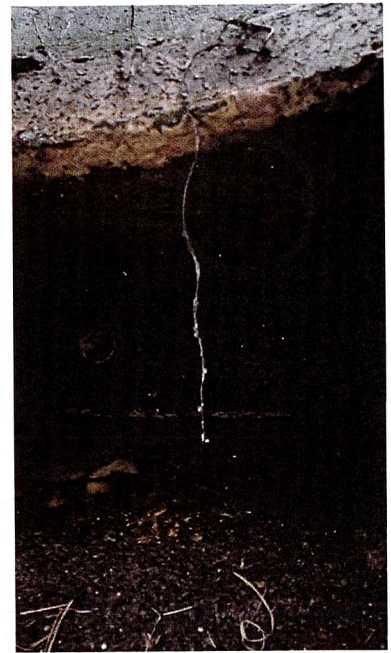
Tank Condition

Is Tank Structurally Sound?: Yes No

Cracks/Visible Gaps on Interior of Tank?: Yes No

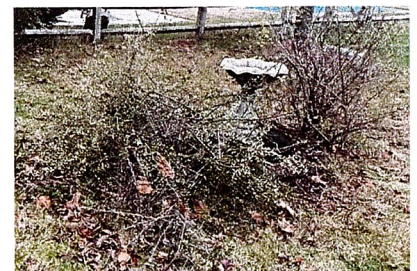
🎯 (SIR-5) Invasive Roots:

Are there roots near or around the system?: Yes No

Per our conversation, be mindful of the nearby established shrubs for invasive roots.

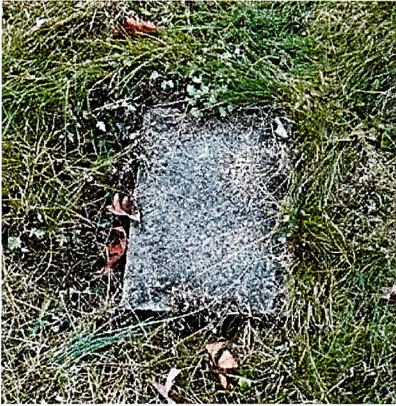
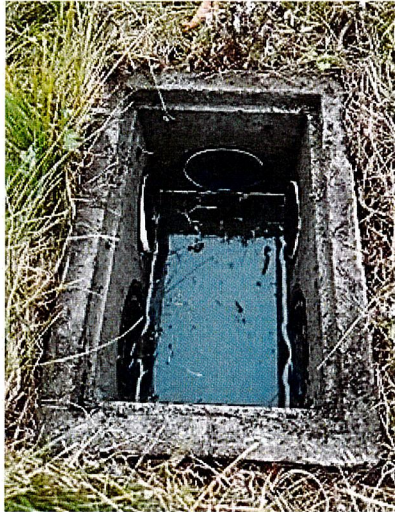
Distribution Box

Condition: Good Fair Poor Not Visible N/A

Distribution Box(es) to grade?: Yes No N/A

Distribution Box(es) Overfull?: Yes No N/A

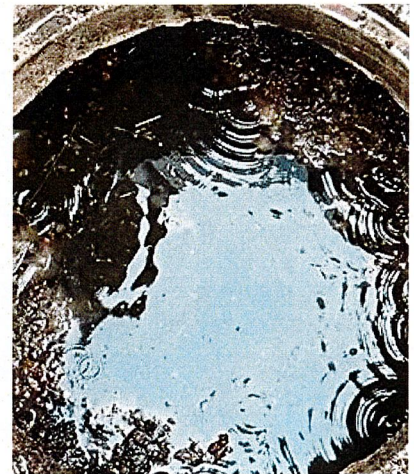
Effluent

Visual Quality: Clear Cloudy Gray Black Not Visible N/A

Depth to Effluent: 10" -12"

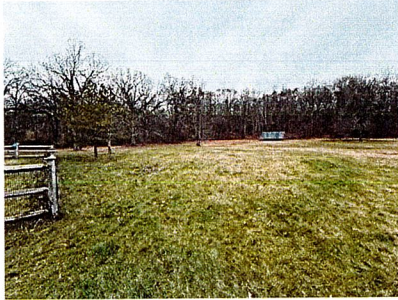
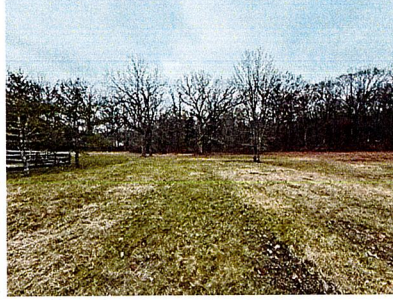
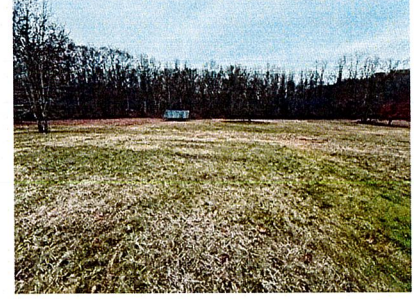
Absorption Area

Type: Leaching Trenches Leaching Pit Infiltrators Galleys/Galleries Other N/A

Surfacing/Ponding?: Yes No N/A

Does property have an expansion area?: Yes No N/A
