Inspection report for the property at
60 Kisor Rd, Highland, NY

This report is prepared exclusively for **Malgorzata Sokolowska**
Inspected On: **11-21-2025**

NY ENVIRONMENTAL SEPTIC INSPECTIONS
(914) 233-7575

Septic Inspection Report

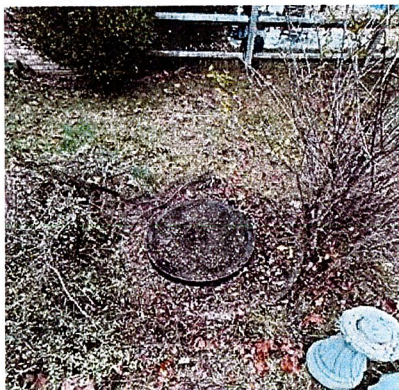
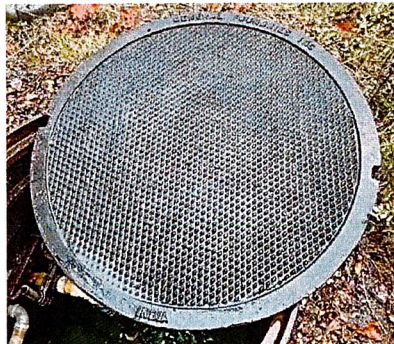
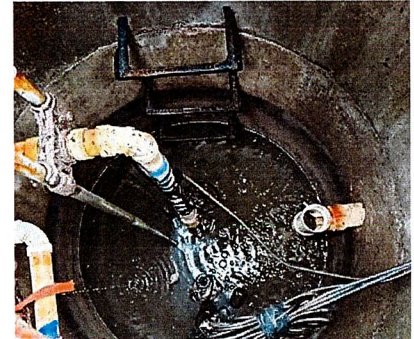
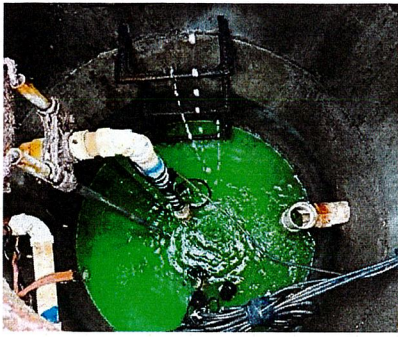
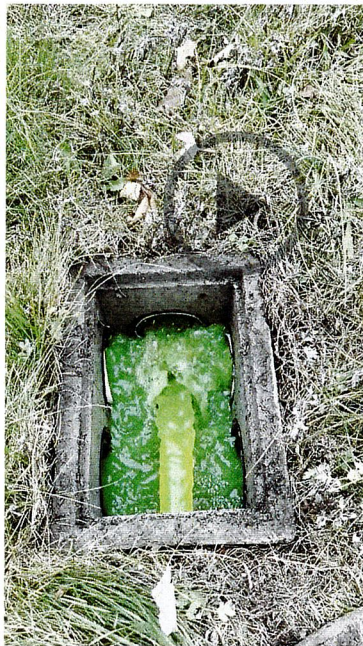
Additional Components

Does system have a pump chamber?: Yes No N/A

Does system have a holding tank?: Yes No N/A

Does system have a syphon tank?: Yes No N/A

Does property have a drywell?: Yes No N/A
